Technical Service Information

TSI-03-01-01R

Subject File: FRAME

Subject: Frame Reinforcements

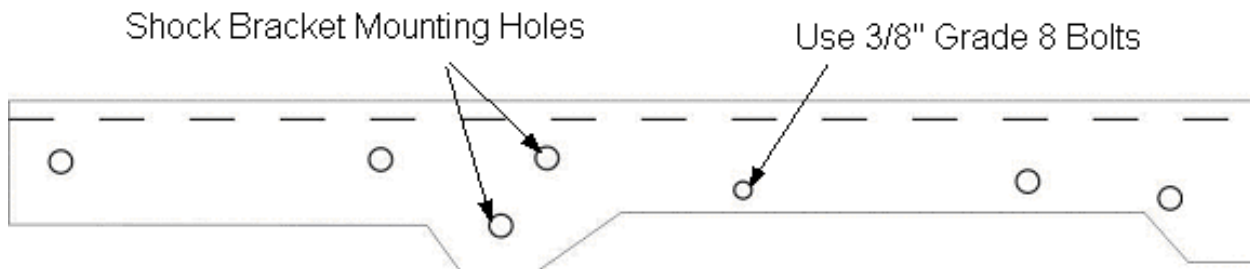
Figure 1 Local Reinforcement — Shock Area

For repairing vehicle frames that have a crack in the engine compartment (shock mounting bracket area) or at the body mount there are now two different style frame reinforcements available. For repairing vehicles with cracks in the frame rail in the Engine Compartment (Figure 1), you should use the below listed Local Reinforcements. For repairing vehicles that have a crack at the body mount area (Figure 2) you should use the below listed Frame Reinforcements.

It is not mandatory for either of the frame reinforcements to be installed. They should only be installed if there are cracks by the front shock mount or in the case of the bus cowl, the cowl mount or at the front body outrigger. It is important to stop drill and weld the crack prior to installing the frame reinforcement. To properly weld the frame refer to the procedure in S01001v Service Manual.

Use 1/2 inch flange head grade 8 bolts in all holes except where otherwise indicated. Tighten 1/2 inch bolts to 110 to 120 lbf-ft. (149 to 162 Nm). Tighten 3/8 inch bolts to 34 to 38 lbf-ft. (46 to 51 Nm).
